3423 Ramsgate Terrace, Alexandria, VA 22309

RE: Mold Inspection of 49 Park Place on September 15, 2015

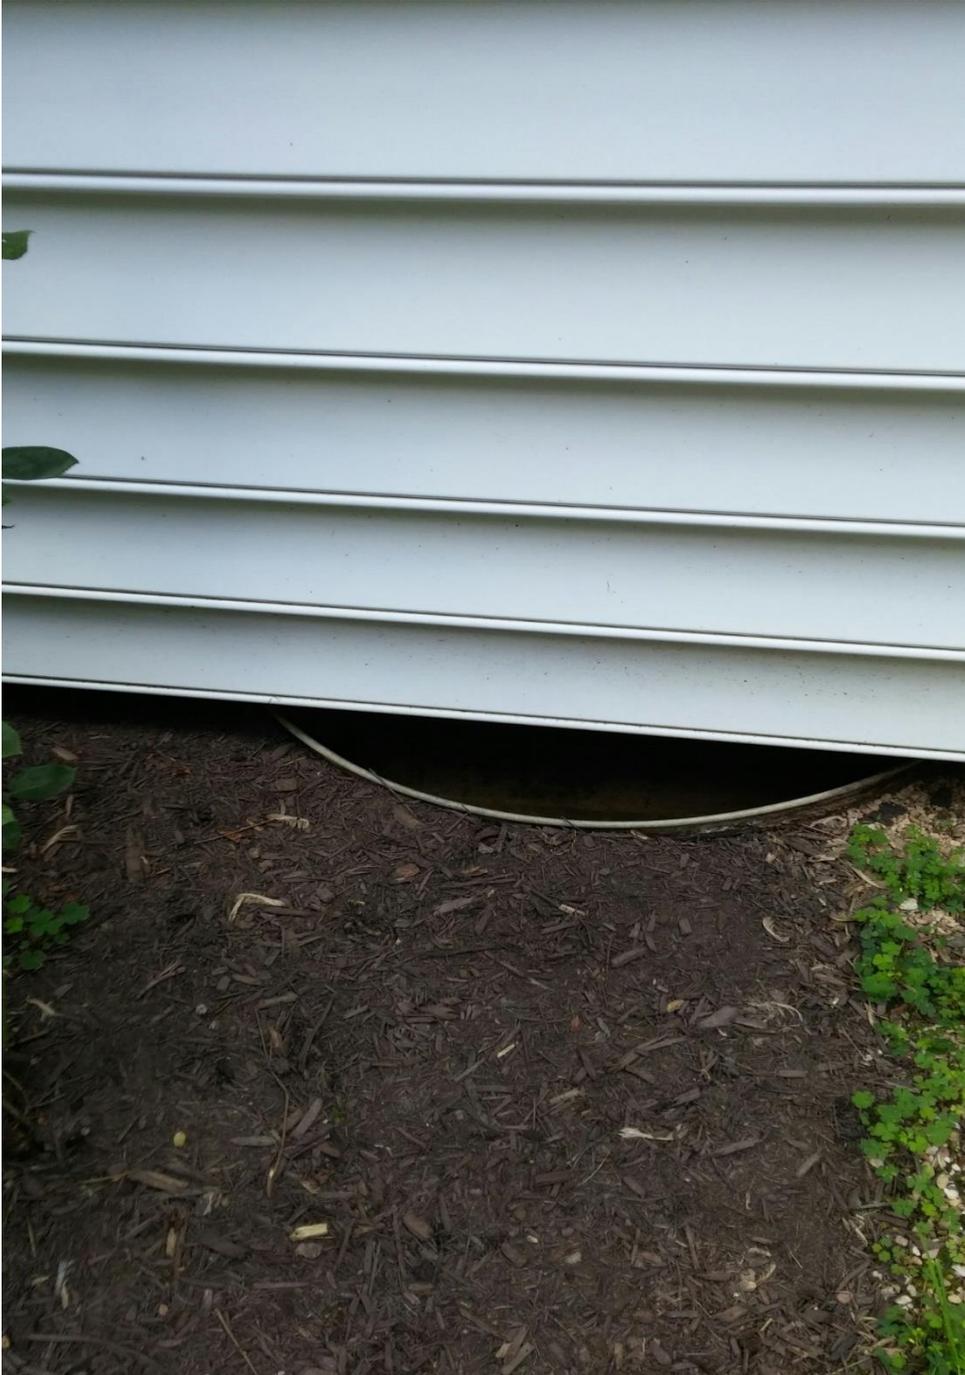
The only area where moisture was clearly evident behind the drywall was below a covered over window in the small room in the basement. Reaching in to examine the old window frame clearly showed it wet and deteriorating. An examination outside showed there was no cover on the well with the siding draining directly over it.

Window well catching siding overflow.

- 1) Covering the window well may help prevent water from overflowing the old window sill, however, the whole opening is clearly compromised and replacement of the window is probably the only way to assure that water cannot enter through that opening. Raising the sill with pressure treated lumber may also help. The well will most likely have to be enlarged to access the opening, which will be an added benefit in providing more light, if that is the case.

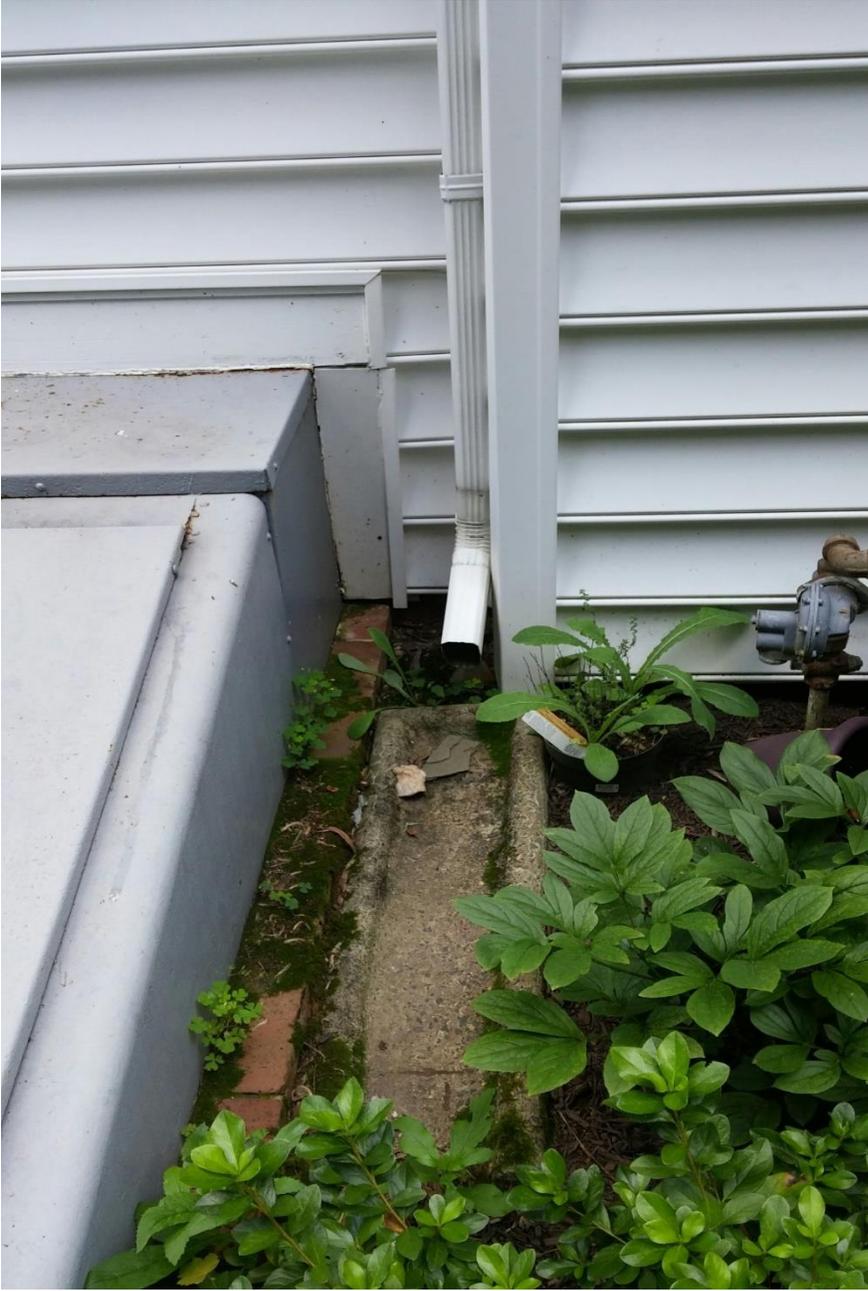
Downspout extension needed here.

- 2) To the left of the well there is a downspout that may be draining backwards. A downspout extender there is suggested.
- 3) To the right of the well is a downgraded set of concrete blocks. This area needs to be regraded with non-porous soil. The mulched area around the well may also require regrading.

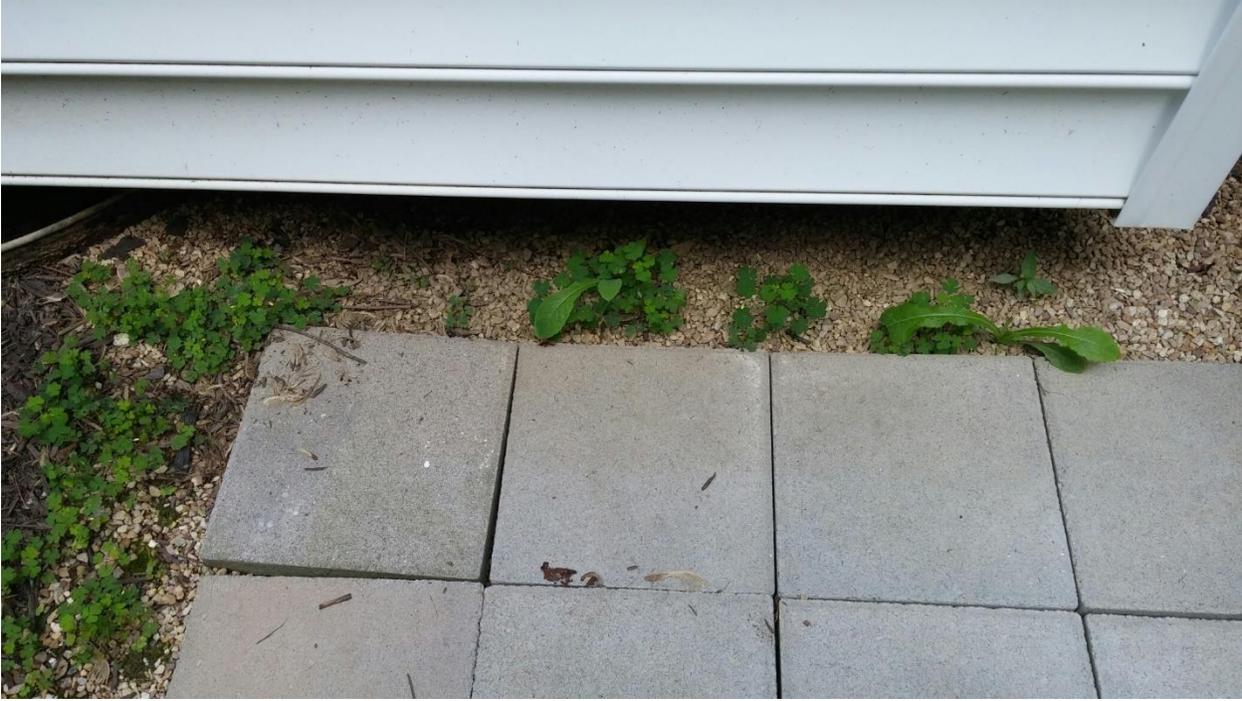
Re-grading needed here.

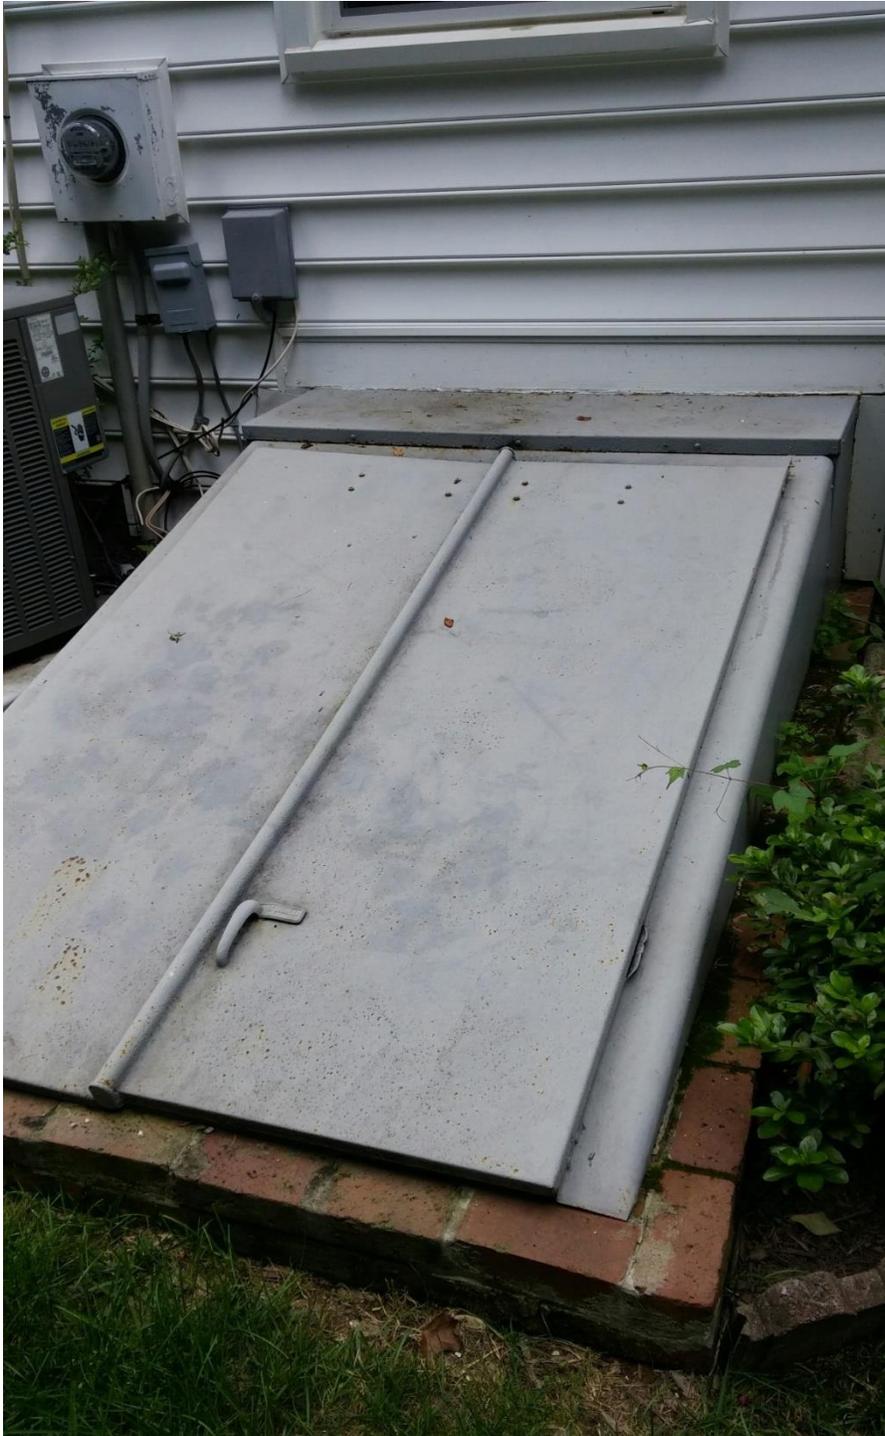
- 4) The stairs are very wet and musty. Removing the cover to allow them to dry and air out may significantly improve the air in the basement. The seal around the stairs at the siding is questionable. Resealing this may keep water from intruding into the basement. If the cover is permanently removed they can actually be made to look good. Such as :

Stairwell cover can be removed or resealed.

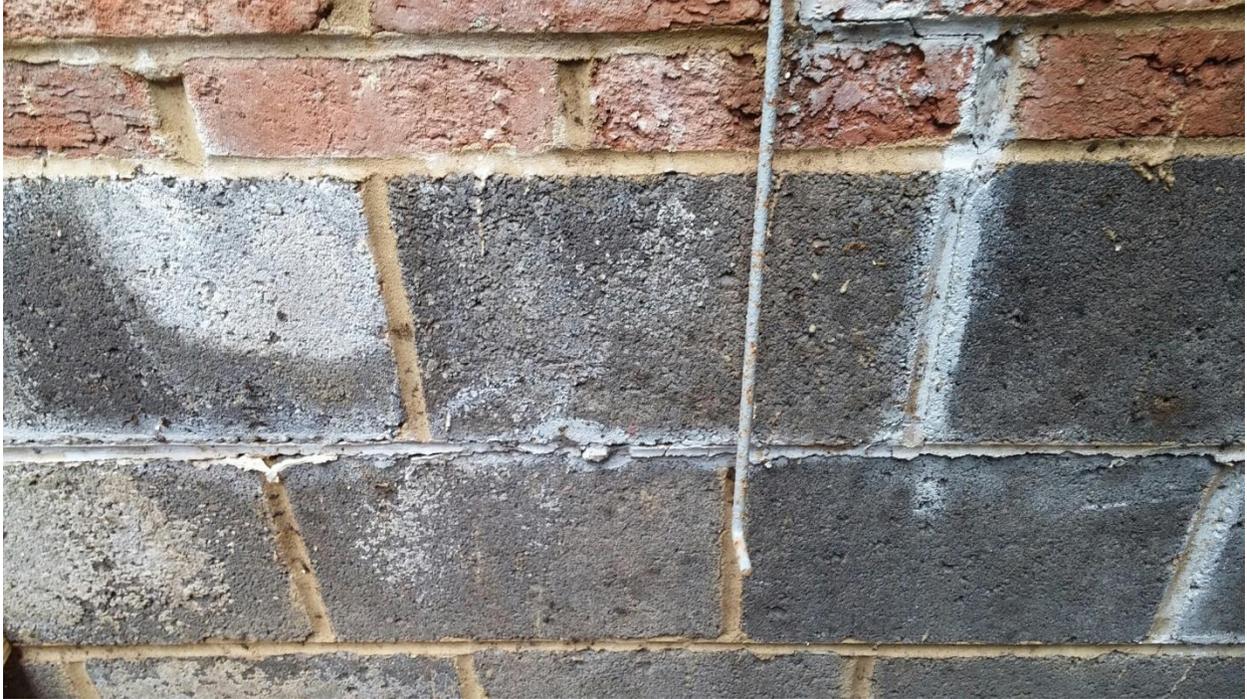
- 5) The basement stairs wall has shifted and a repair was attempted. Further water intrusion damage can be limited by waterproofing the walls as explained in:

Basement stairwell needs to be waterproofed.

Epoxy injection can stabilize the crack as explained here:

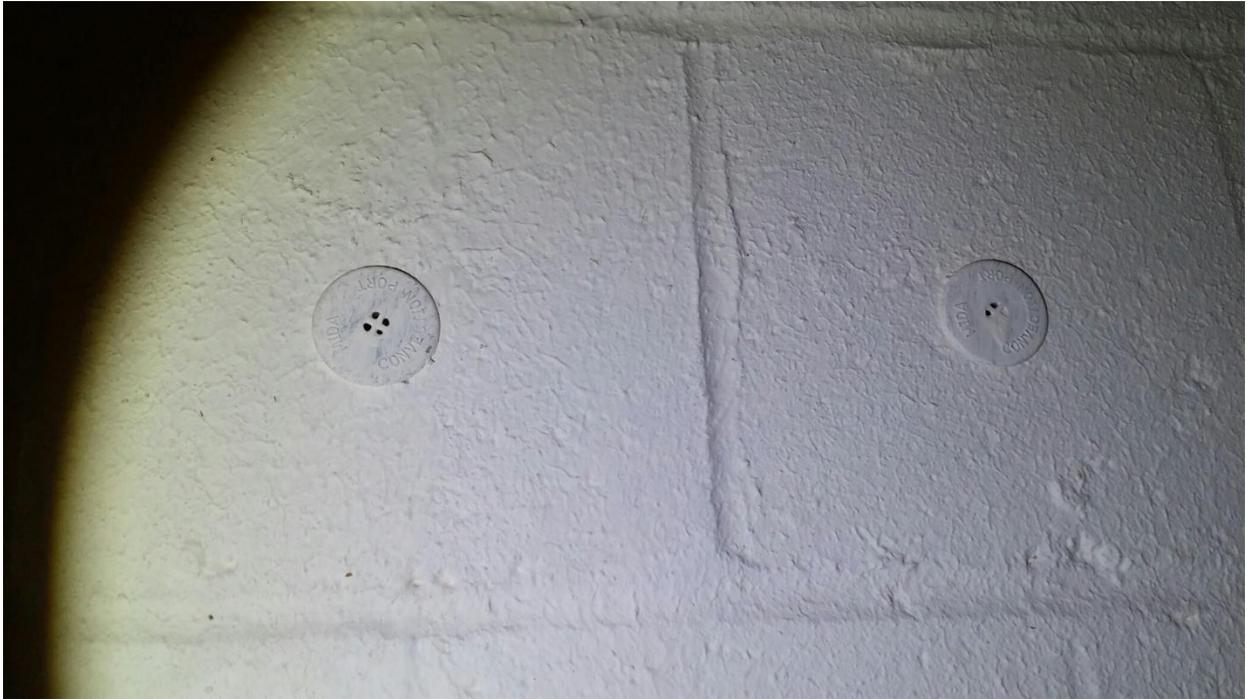
These vents need to be cleaned.

- 6) Two of the walls in the utility room show efflorescence and other signs of water intrusion. They should be waterproofed in the same way as the basement stair wall.
- 7) Some plugs to allow the walls to breathe have been installed in the utility room. These have been painted over, drastically reducing their effectiveness. These holes can be opened using a nail.
- 8) A dehumidifier was used previously to get rid of the moisture getting through the walls. These use a lot of electricity, need constant maintenance and don't get rid of other pollutants. I recommend that a humistat fan be installed in the utility room. This model requires two holes be cut in the wall, similar to what would be required for two dryer vents.

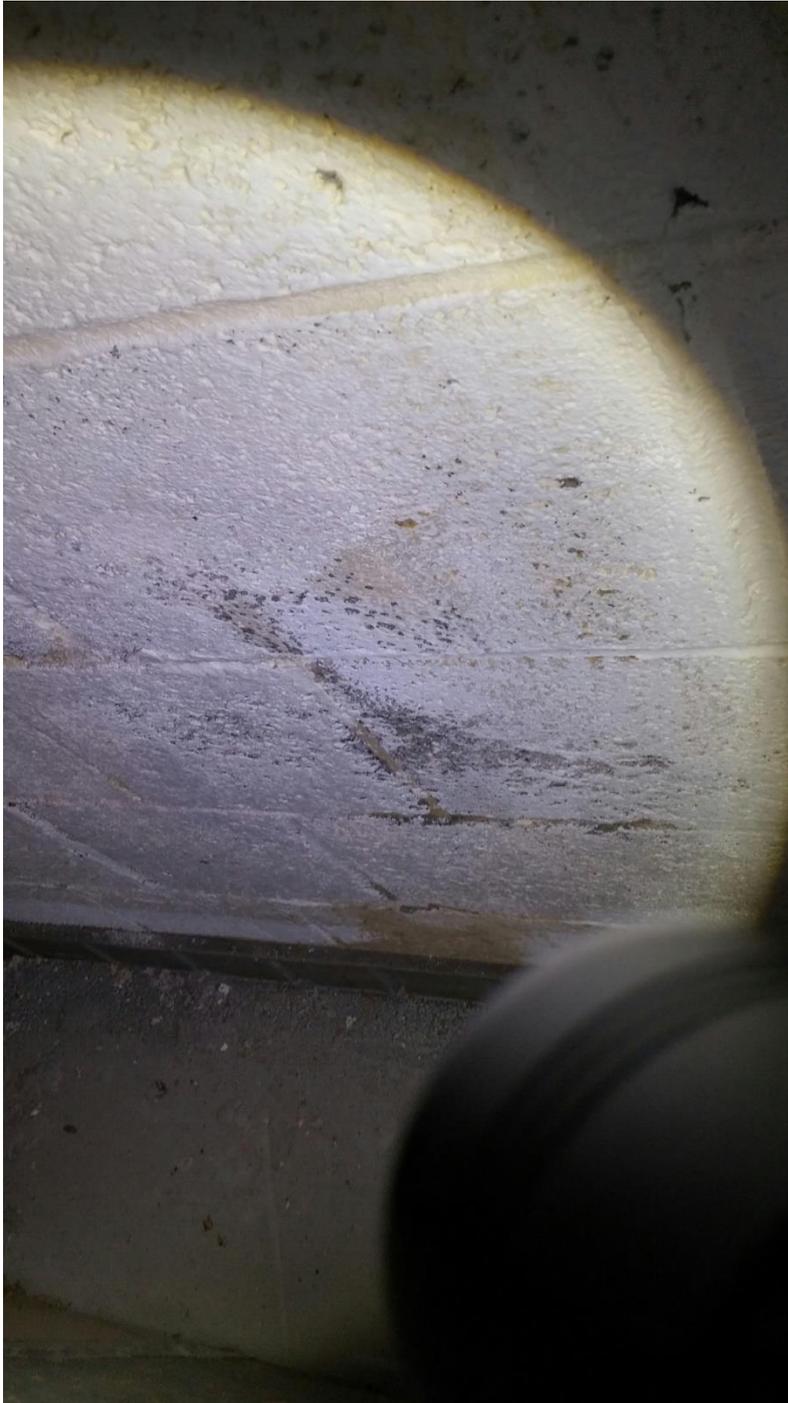
This is indicative of efflorescence found all along wall behind furnace. Probable Aspergillus/Penicilium here.

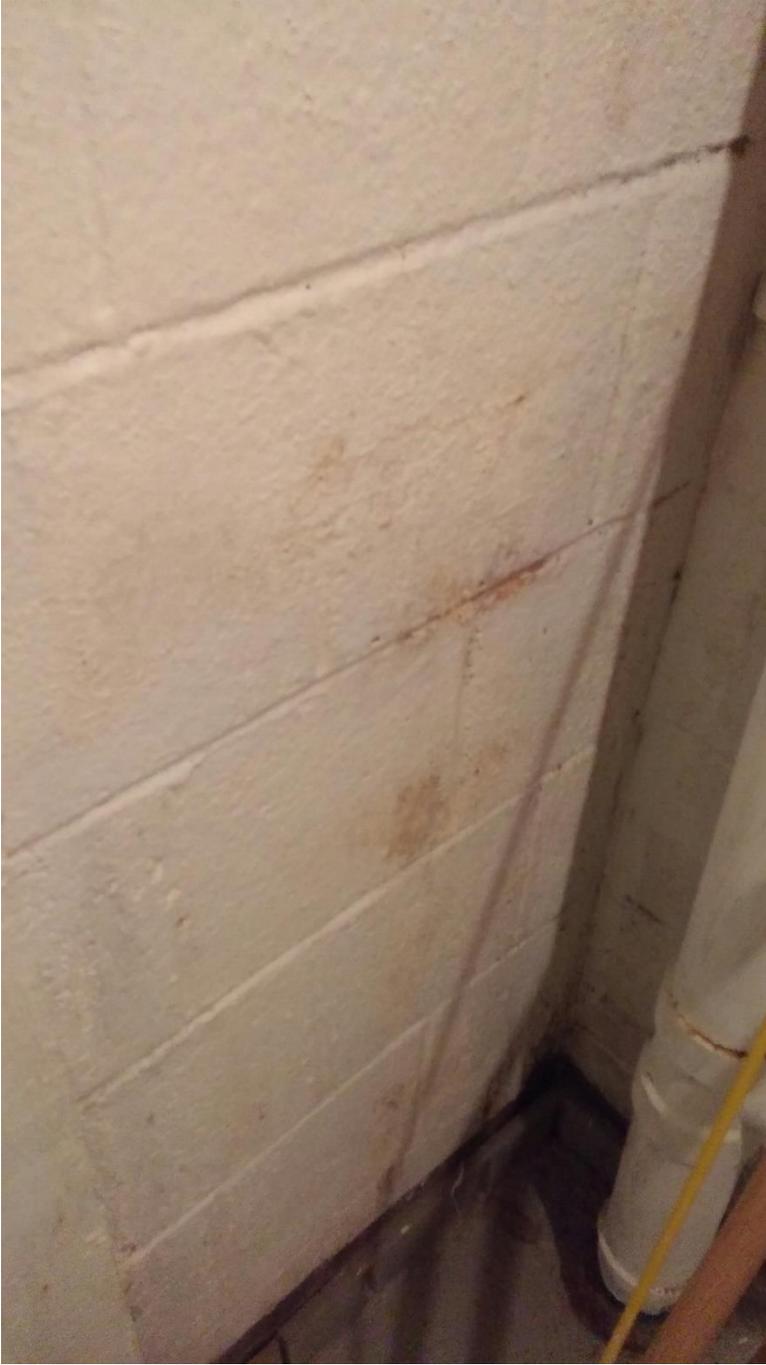
Water intrusion in outer corner of utility room.
