3423 Ramsgate Terrace, Alexandria, VA 22309

RE: Mold Inspection of 49 Park Place on September 15, 2015

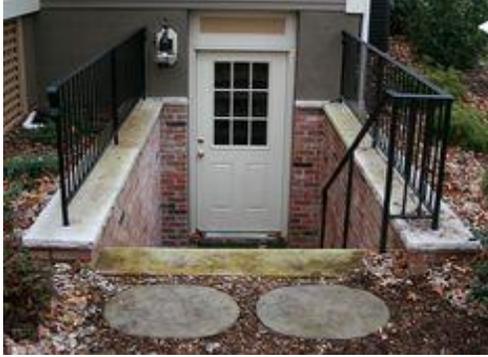
- 4) The stairs are very wet and musty. Removing the cover to allow them to dry and air out may significantly improve the air in the basement. The seal around the stairs at the siding is questionable. Resealing this may keep water from intruding into the basement. If the cover is permanently removed they can actually be made to look good. Such as :
